PRELIMINARY REPORT  
FOR  
COMMONWEALTH OF PUERTO RICO  
DEPARTMENT OF PUBLIC WORKS  
AND  
PUERTO RICO PLANNING BOARD

FLOOD CONTROL STUDIES  
HUMACAO RIVER  
HUMACAO, PUERTO RICO

CESAR S. CANALS ASSOCIATES  
CONSULTING ENGINEERS

APRIL, 1969

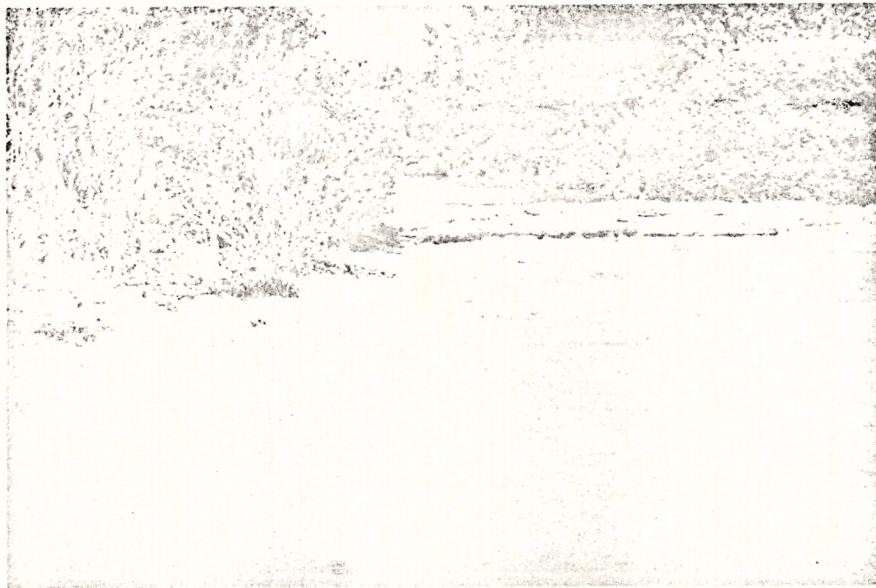
View of the mouth of the river closed by sand accretion.

The strong winds of hurricane "Donna" in 1960, produced very high waves that retarded the discharge of the river into the sea. This condition is being made worse nowadays by the extraction of sand from the protective sandbar and the beach existing on both sides of the mouth of the river.

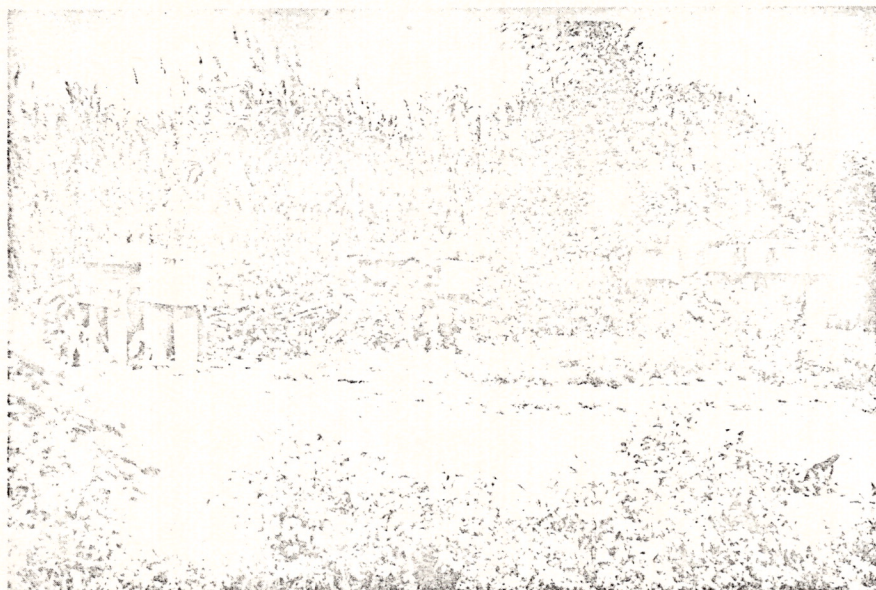
View of the remains of an old P. R. bridge destroyed by the 1960 flood. Taken looking upstream.

The flood damages that would result today from recurrences of major known floods would be even more severe than heretofore because of the present condition of the river channel. The 1960 flood destroyed all the bridges crossing the Humacao River except for the bridge on State Route 923. The bridge on Route 3 that was destroyed by the 1960 storm has been replaced by a larger and higher structure that will pass the peaks from large floods safely. However, the piers of the four railroad bridges that were destroyed downstream from the Route 3 crossing still remain in place and are completely covered with bamboo trees and other vegetation. Photographs in the Appendix to this report illustrate the conditions of these piers and of the present river channel.

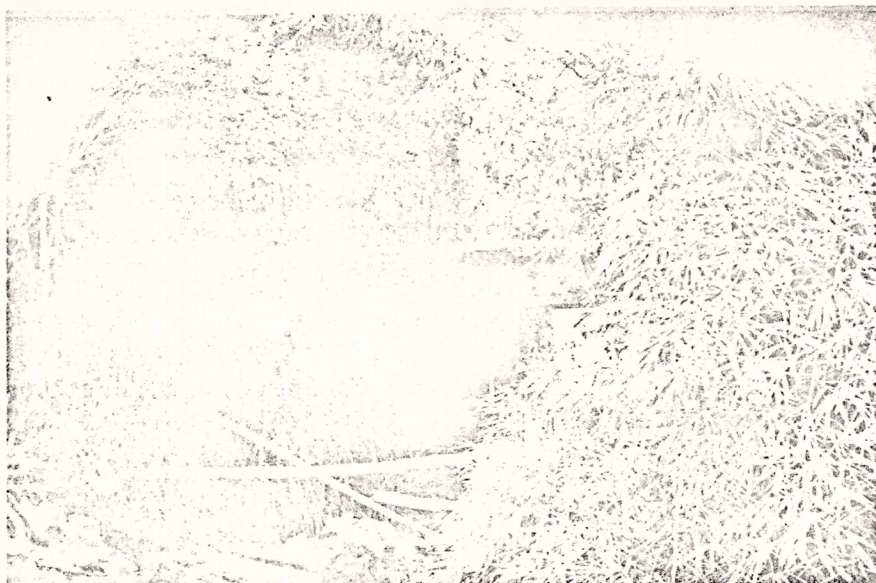
View of old P. R. bridge covered by bamboo trees and other vegetation. This bridge was partially destroyed by the 1960 flood. Taken looking downstream.

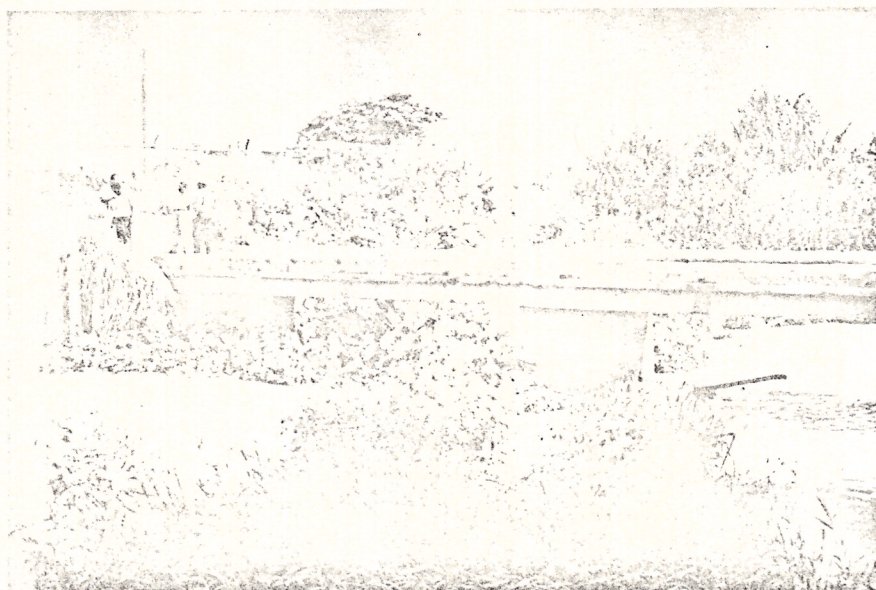
View of old bridge on Route 923 looking downstream. Destroyed during May 21, 1969 storm.

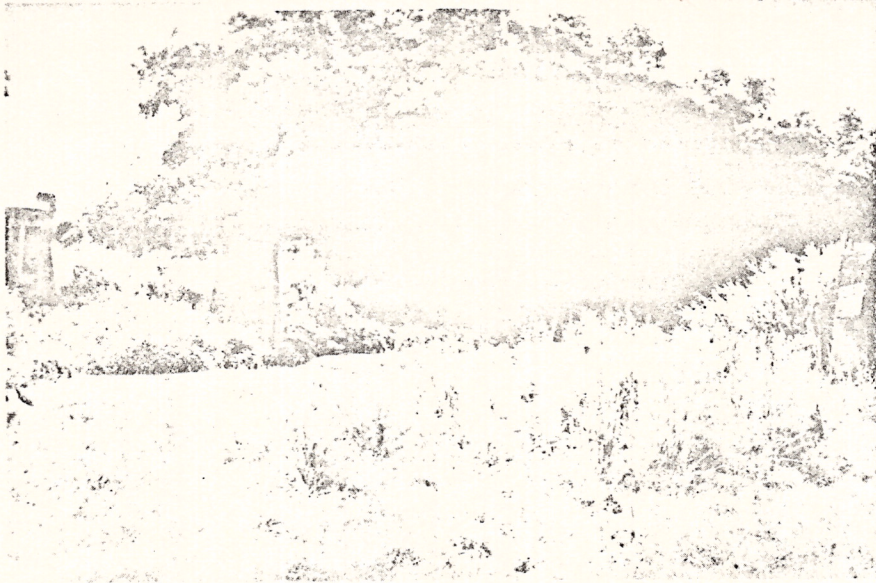
View of the remains of an old P. R. bridge destroyed by the 1960 flood. Taken looking upstream.

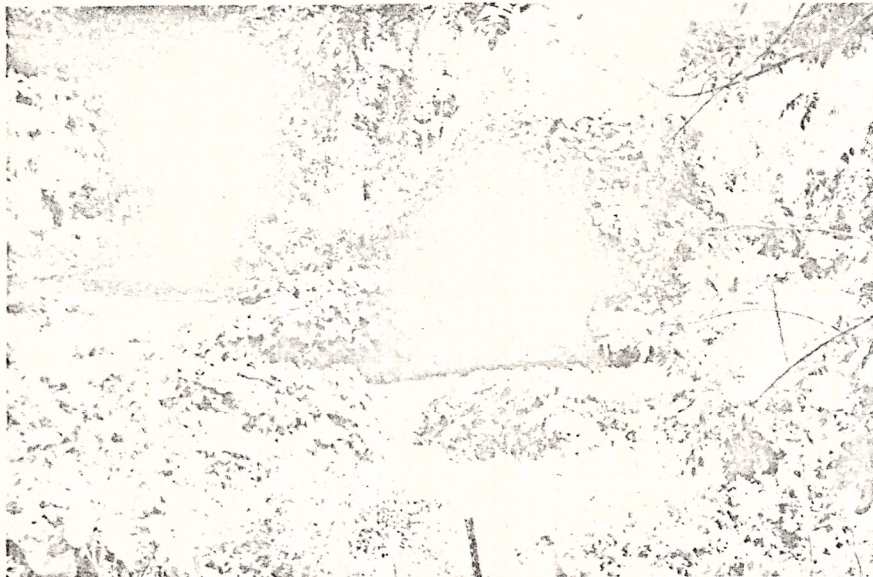
View of vine covered piers of old P. R. railroad bridge destroyed by the 1960 flood.

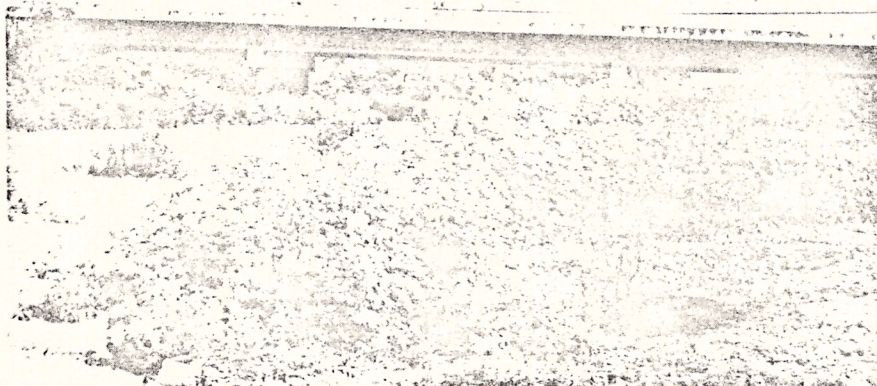
Bridge on State Route No. 3 built in 1961, after the 1960 flood washed away the old bridge at the site.

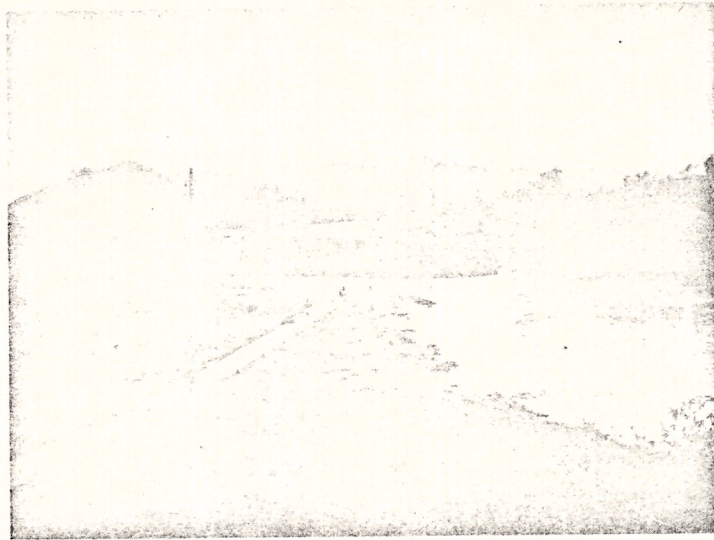
View from the New Shopping Center in Humacao looking at a pedestrian crossing built by placing 36" concrete pipes across the river.

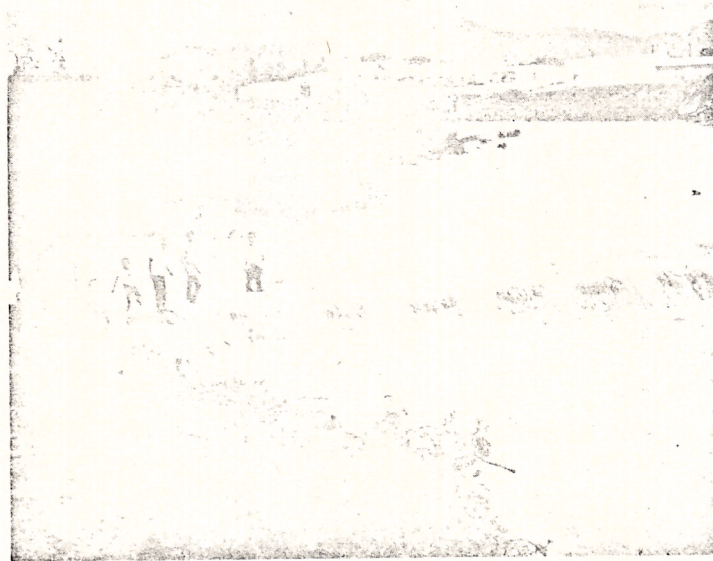
View of pedestrian crossing from south bank of the Humacao river to the new Shopping Center in Humacao.

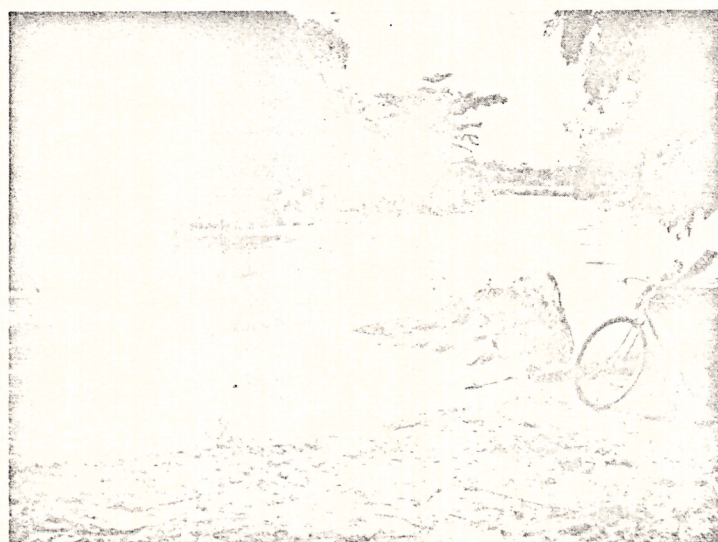
Bridge on Route 923 in Humacao spared by the 1960 flood of the Humacao River was washed out on May 21, 1969.

the 1960 flood this bridge was blocked by trash and sediment and the flood waters overtopped it and spilled into the sugar cane fields depositing large amounts of sediment that damaged the crop of that year. After careful consideration given to the future street layouts for the town of Humacao (See Planning Board Plan dated January 13, 1969) where three bridges are proposed to cross the Humacao River, it is recommended that the construction of the most easterly bridge be accelerated and rerouting of State Route 923 along higher grounds across this bridge be effected. (See Plate 19).

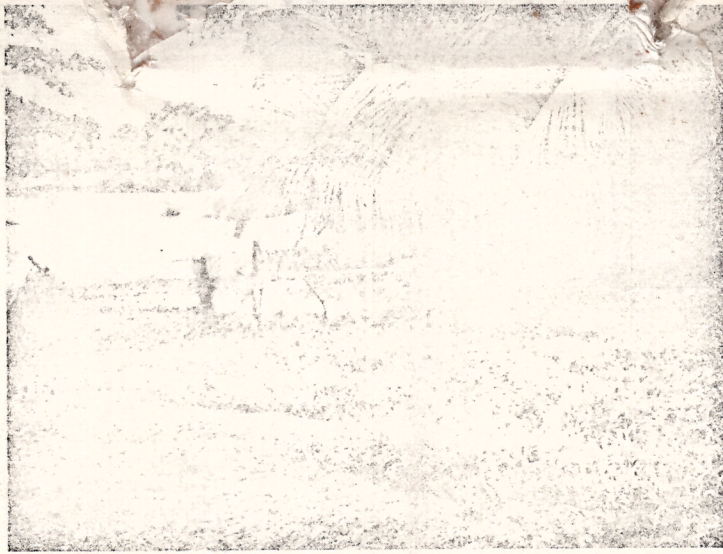
View of the confluence of Mabú creek and the Humacao  
River swollen by floodwaters on May 21, 1969.
